Manhole Inspection Summary

Manhole # S05EE2007MH

Insp Date: **7/17/06 8:24 AM**

Location Address: **2702 BARTOL AVE**

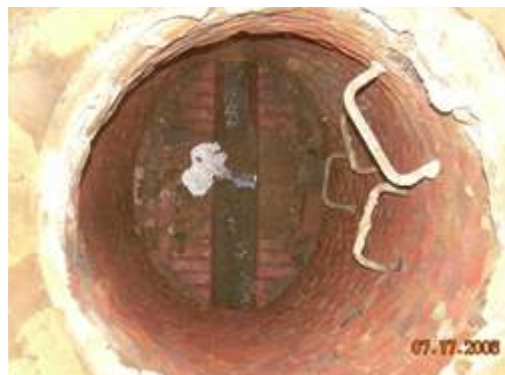
Top View

Frame leaks. Adjustment deterioration and loose brick. Adjustment and Barrel infiltration. Evidence of surcharge - Bench

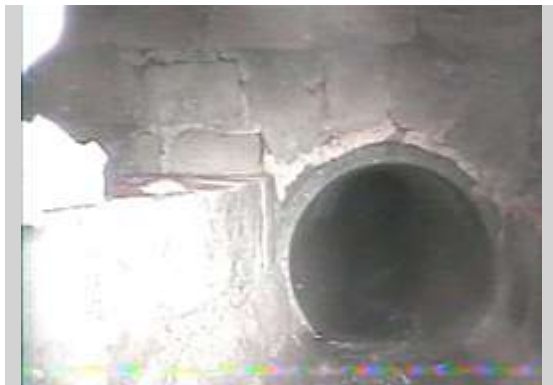
Pipe Out @ 12 O'Clock

Comments **The O12 pipe picture shows Barrel deterioration and infiltration. The O12 pipe seal is not flush to the pipe.**

Infiltration: **Evidence** Pipe Seal Cond: **Cracked**

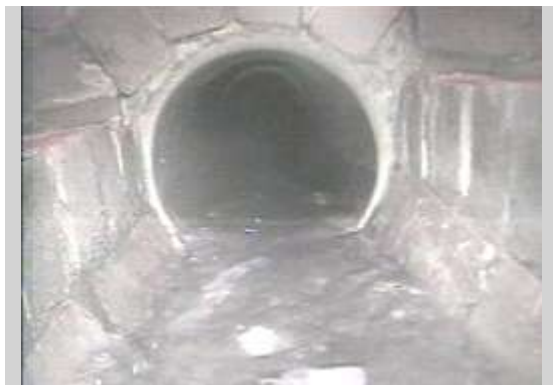
Pipe In @ 6 O'Clock

Infiltration: **Evidence** Pipe Seal Cond: **Cracked**
